# DECAY OF THE RESTORATION RENDER MORTAR OF THE CHURCH OF SAN MANUEL AND SAN BENITO, MADRID, SPAIN: RESULTS FROM OPTICAL AND ELECTRON MICROSCOPY

M.J. Varas<sup>a</sup>, M. Alvarez de Buergo<sup>b</sup>, E. Perez-Monserrat<sup>b</sup>, R. Fort<sup>b</sup>

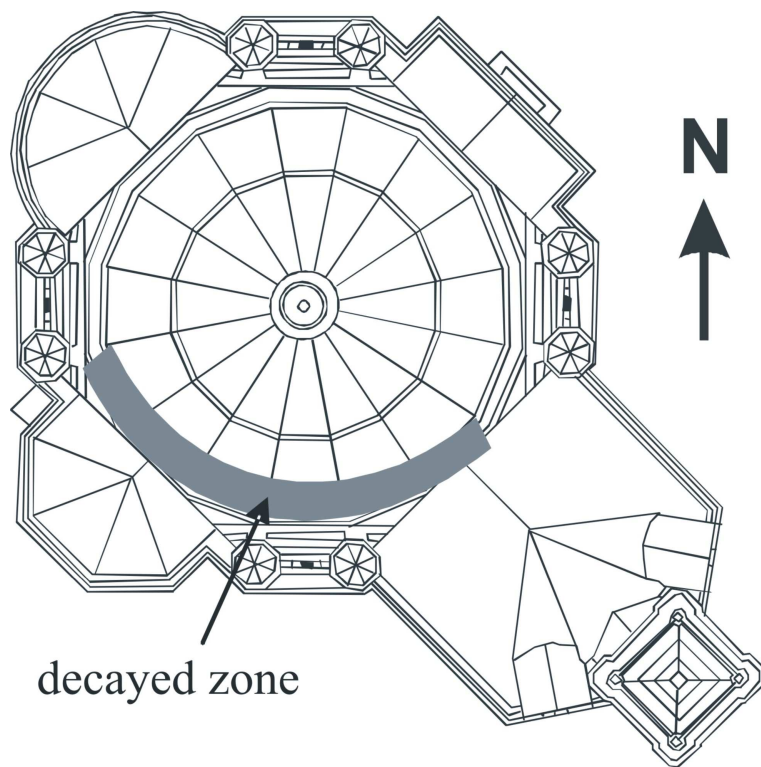
Fig. 2. Ground plan of the building.

At present, the restoration render mortar is extremely degraded in the drum area, with bulging and fissuring that sometimes lead to the complete detachment of mortar fragments of significant volume (Fig. 3). These breakages are severe in the upper areas oriented W, SW, S and SE (Fig. 2) and are mainly located under the windows level of the drum (Fig. 6) and at the slope change with the roofing of the side chapels (grader area, Fig. 3).

Environmental conditions play an important role as the more deteriorated upper zones coincide with the zones which are more exposed to sun radiation (S and SW) and become significantly hotter than environmental temperatures (Fig 2).
